## Devil's Slide/Hwy 1 Storm Repair

Daily Updates from Bijan Sartipi

**Daily Update**  
July 10

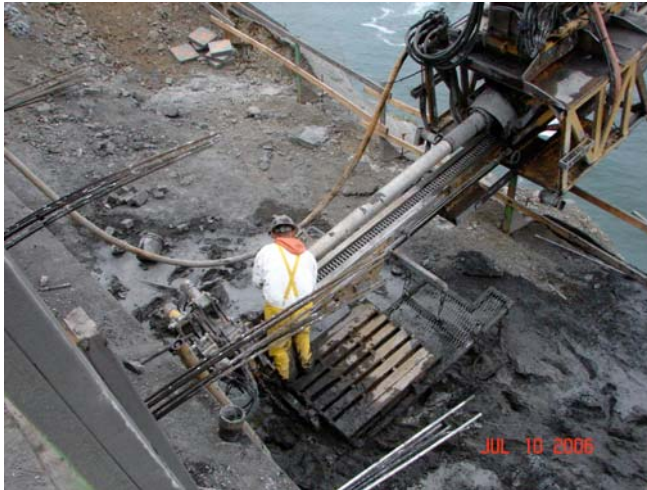
- Level 'B' (lower level ocean side) – Drilling for tie backs continued using the reach over rig. 53 of 58 tie backs now installed. Tie back stressing also continued.

Drilling at level B with reach over rig

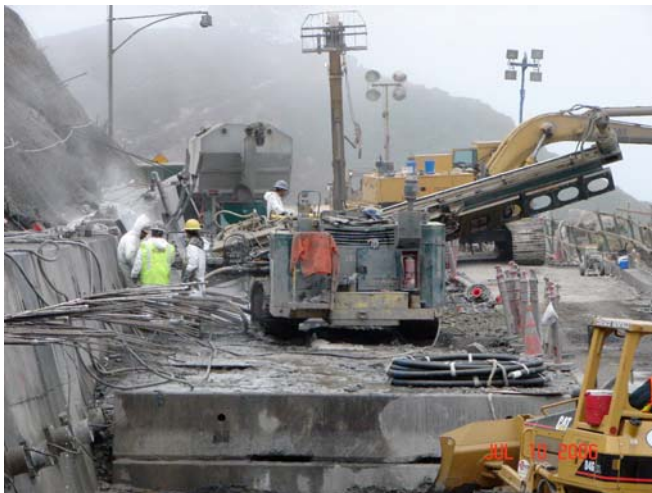
- Level 'C' (lower level cliff side) – Tie back stressing was completed today.
- Level 'D' (upper level cliff side) – Drilling for tie backs continued today from the temporary bench. 22 of 33 now installed.

Drilling at level D

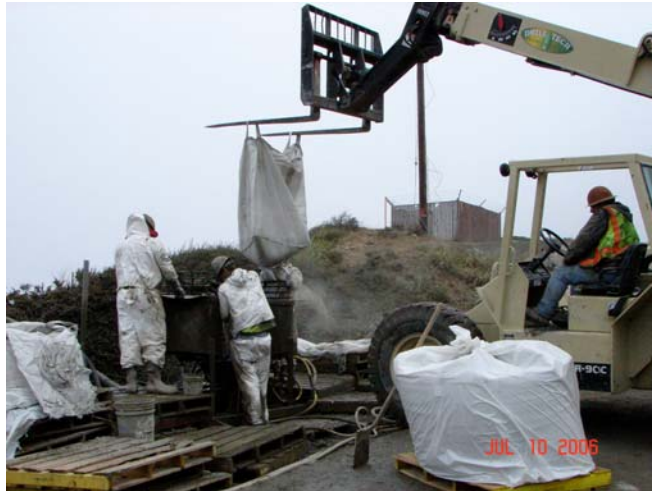
- Drilling and driving steel piles continued today. 39 of 99 now installed.

Cement mixing for the micropile wall operation
